SERVICE BULLETIN

Service Bulletin No. 627E
 Supersedes Service Bulletin No. 627D
 Engineering Aspects are
 FAA Approved

SUBJECT: Exhaust System Inspection

MODELS AFFECTED: Lycoming Engine Model TIO-540-AJ1A

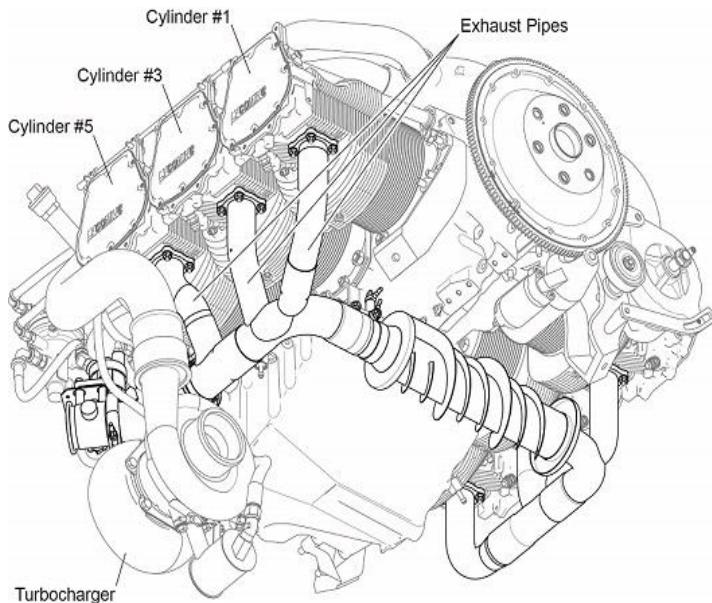
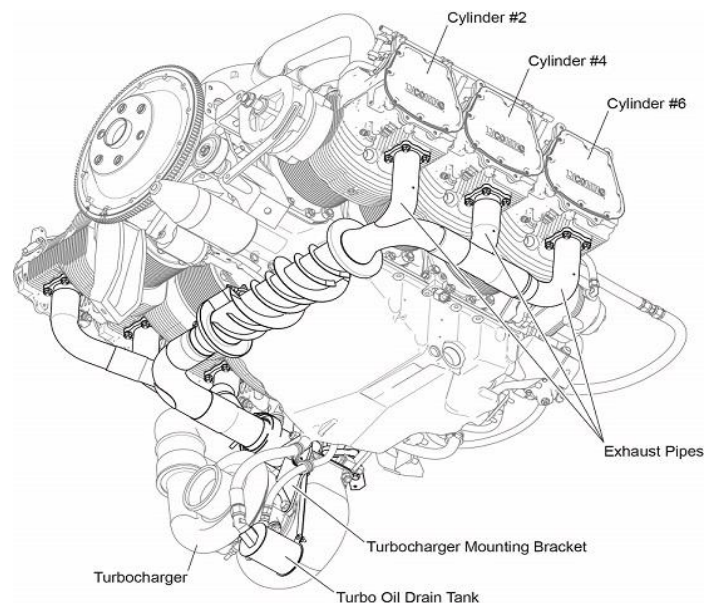
Figure 1
Exhaust System (#1, #3, #5 Cylinder - Right Side of Engine)

Figure 2
Exhaust System (#2, #4, #6 Cylinder - Left Side of Engine)

- E. Complete a visual inspection on the entire exhaust system (Figures 1 and 2). If any sign of leaks, distortion, or damage is found, document the issue then replace with serviceable parts.
- 2. Flange Nut Torque Check
 - A. Since loose flange nuts can be an indication of a potential exhaust leak, complete a torque check on exhaust system flange nuts for all six cylinders.
 - B. If a flange, stud, flange nut, or pipe is distorted or visibly damaged, document the issue then replace with serviceable parts. If it is just a leaky gasket, determine root cause, and replace the gasket and hardware with new parts.
 - C. Check the fractional amount each flange nut turns to achieve the required 96 in.-lb (11 Nm) torque. If any flange nuts are loose enough to allow movement of the washer, contact Lycoming Engines' Product Support.

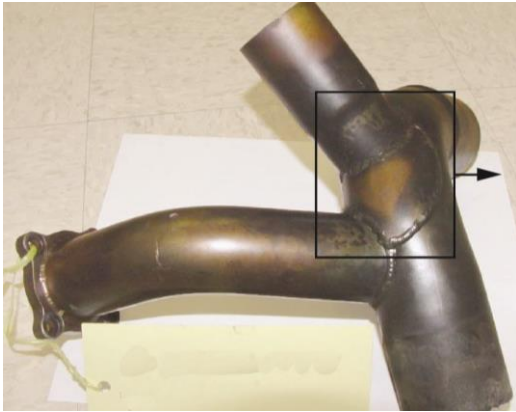
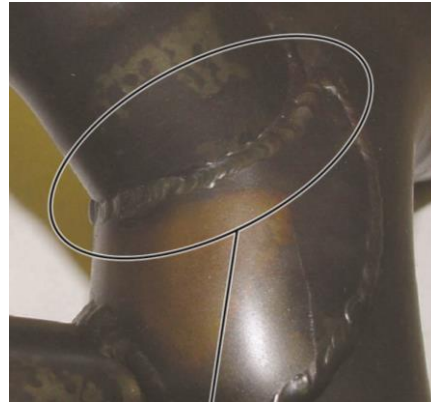
Figure 11
Saddle

C. Examine the weld joints of the exhaust pipes for all cylinders (Figures 1 and 2). Closely examine the saddle reinforced weld joints (Figures 11 and 12), especially at Cylinder 3. If any cracks or damage is found, document the issue then replace with serviceable parts.

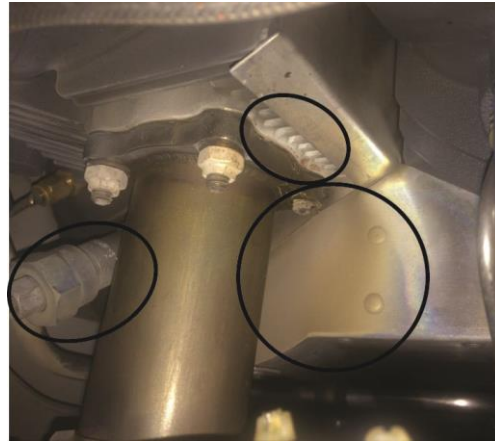
D. Examine all cylinder exhaust flanges (Figure 13) for damage, distortion, or signs of exhaust gas leaking past the gasket, especially at Cylinder 2. Indications of a flange gasket leak are burnt paint around the exhaust flange bosses or powdery white to light brown or black residue near the leaks, on the spark plug, and the baffle. If the flange or pipe is distorted or damaged, document the issue then replace with serviceable parts.

Figure 13
Signs of Exhaust Leak

⚠ WARNING: DO NOT OPERATE THE AIRCRAFT WITH A LEAKING ENGINE EXHAUST SYSTEM. OPERATION OF THE AIRCRAFT WITH AN EXHAUST SYSTEM LEAK CAN LEAD TO CARBON MONOXIDE POISONING, LOSS OF CONSCIOUSNESS, INJURY, OR DEATH.
