MANDATORY SERVICE BULLETIN

Service Bulletin No. 366B
(Supersedes Service Bulletin No. 366A)
Engineering Aspects are
FAA Approved

SUBJECT: Carburetor Throttle Body Screw Inspection

MODELS AFFECTED: All Lycoming engines equipped with Marvel-Schebler, Facet, Precision, or Volare updraft carburetor models MA-3A, MA-3PA, MA-3SPA, MA-4SPA, MA-4-5, MA-4-5AA, and MA-6AA.

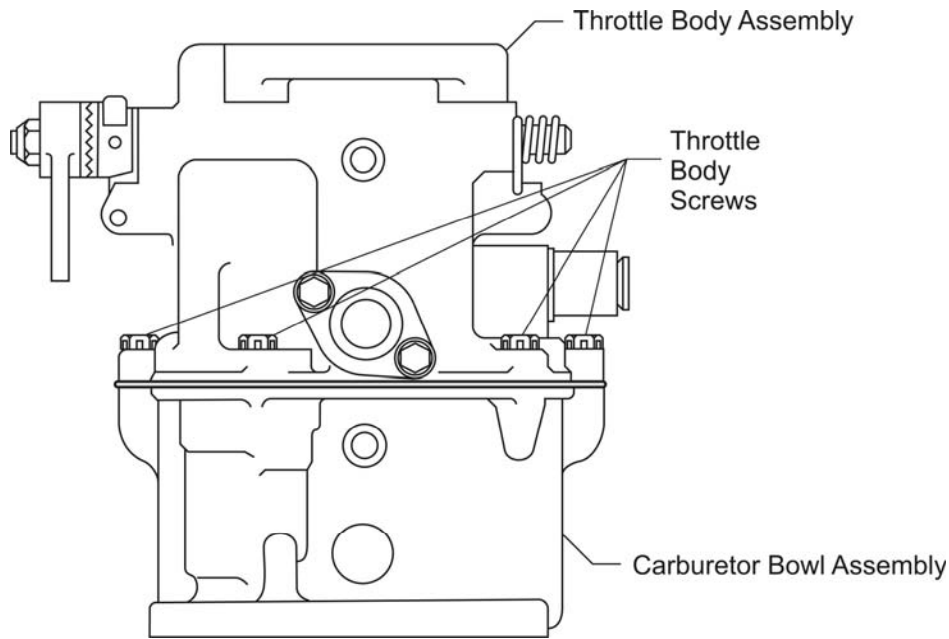
Figure 1. Illustrative Example of Throttle Body Attaching Screws

Instances have been reported of leakage through the gasket between the bowl assembly and throttle body of the carburetor, evidenced by fuel stains in the area of the leak. Leakage of this type may be accompanied by loose screws that attach the bowl and throttle body.

Models MA-3A, MA-3PA, MA-3SPA, and MA-4SPA have four screws. Models MA-4-5, MA-4-5AA, and MA-6AA have six screws.

1. Check the carburetor for evidence of fuel stains on the outside of the bowl along the parting line.
2. Check for movement between the throttle body and bowl.
3. Check each throttle body to bowl attaching screw for looseness by attempting to move the screw and/or locktab washers with your fingers.

4. If there is evidence of fuel stains, movement between the throttle body and bowl, or the throttle body to bowl attaching screws are loose then remove the carburetor in accordance with the applicable engine and airframe service manuals. Send the carburetor to a qualified repair station for troubleshooting and repair. For the most recent listing of qualified repair stations contact Volare Carburetors at the following:
