Engine Maintenance Manual (Principal Manual)

TEO-540-A1A Engine

Part No. MM-TEO-540-A1A

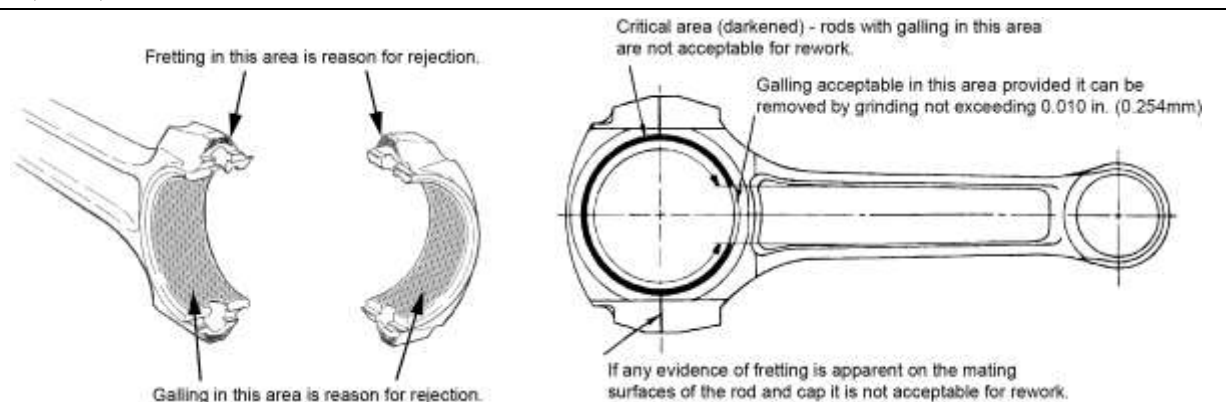
Figure 32 Areas on Connecting Rod to Examine for Fretting and Galling

* Do not mistake stains or discoloration for galling. Surface blemishes are easily removed with a fine abrasive cloth, chemical cleaner or steel wool. Whereas, galling cannot be removed. If galling is found in the bearing bore, replace the connecting rod. If surface blemishes cannot be removed with a fine abrasive cloth, chemical cleaner or steel wool, there is evidence of galling. Gall marks vary in size and shape. Some gall marks can be as small as pin heads. Other gall marks can be circular, oval, thin, or look like rods.

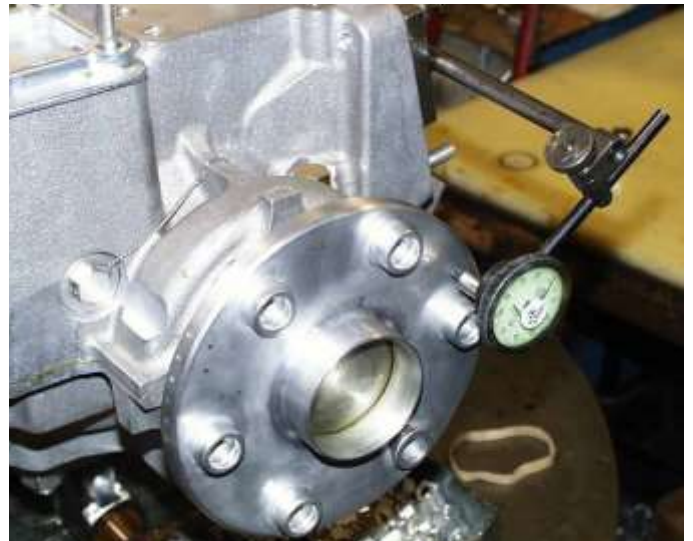
Figure 92
Crankshaft End Play Check

- A. Attach a dial indicator gage to the crankcase starter pad.
- B. Move the crankshaft to the rear of the engine as far as possible.
- C. Position the dial indicator gage on the face of the crankshaft flange (Figure 92) and set the gage to read "0."
- D. Slide the crankshaft forward as far as possible.
- E. Read the end play measurement indicated by the gage.
- F. Set the gage to read "0" with the crankshaft as far forward as possible.
- G. Move the crankshaft to the rear of the engine as far as possible.
- H. Read the end play measurement indicated by the gage.
- I. Both measurements must be the same and the reading must be 0.009 to 0.026 in. (0.229 to 0.660 mm).
- J. If the measurements are not the same or if the end play clearance is not within the limits, disassemble the crankcase and examine the crankcase and/or crankshaft for wear or damage. Replace a worn or damaged component.

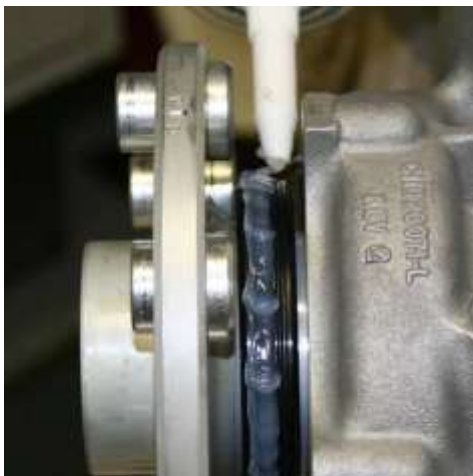
Figure 95
Apply the Sealant to the Oil Seal

- (4) Use a brush and wear butyl rubber gloves to apply a liberal coating of Dow Corning® 737 Neutral Cure Sealant to the outside diameter of the oil seal (Figure 95) to allow the excess sealant to squeeze out between the crankcase and the oil seal when the oil seal is installed.

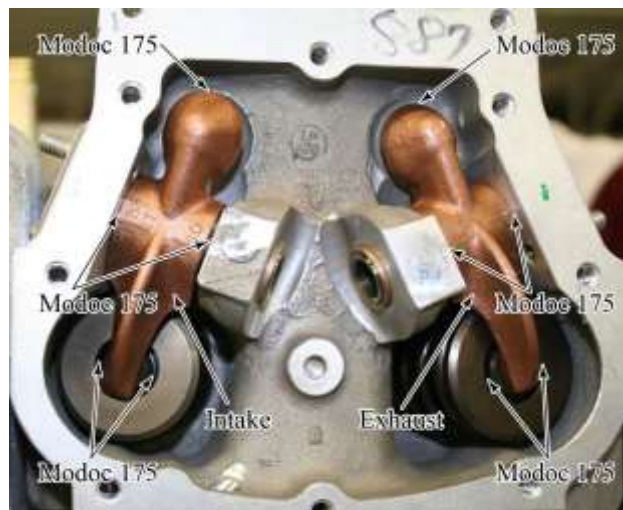
Figure 41
Valve Rocker Lubrication

R. Lubricate rocker contact surfaces (Figure 41) with Modoc[®] Oil 175.

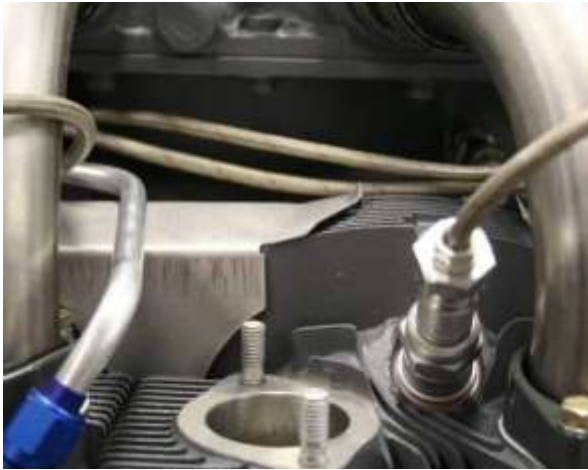
Figure 44
Correct Tight Fit of Intercylinder Baffle

- (4) Ensure the intercyylinder baffles are installed on three fins as shown in Figure 43 as a “tight fit” (as shown in Figure 44) and not loose (Figure 45). It could be necessary to bend the angles of the intercyylinder baffle to ensure a tight fit.
